Tsunami vulnerability of buildings and people in South Java – field observations after the July 2006 Java tsunami

S. Reese¹, W. J. Cousins², W. L. Power², N. G. Palmer², I. G. Tejakusuma³, and S. Nugrahad³

Abstract. A team of scientists from New Zealand and Indonesia undertook a reconnaissance mission to the South Java area affected by the tsunami of 17 July 2006. The team used GPS-based surveying equipment to measure ground profiles and inundation depths along 17 transects across affected areas near the port city of Cilacap and the resort town of Pangandaran. The purpose of the work was to acquire data for calibration of models used to estimate tsunami inundations, casualty rates and damage levels. Additional information was gathered from interviews with eyewitnesses.

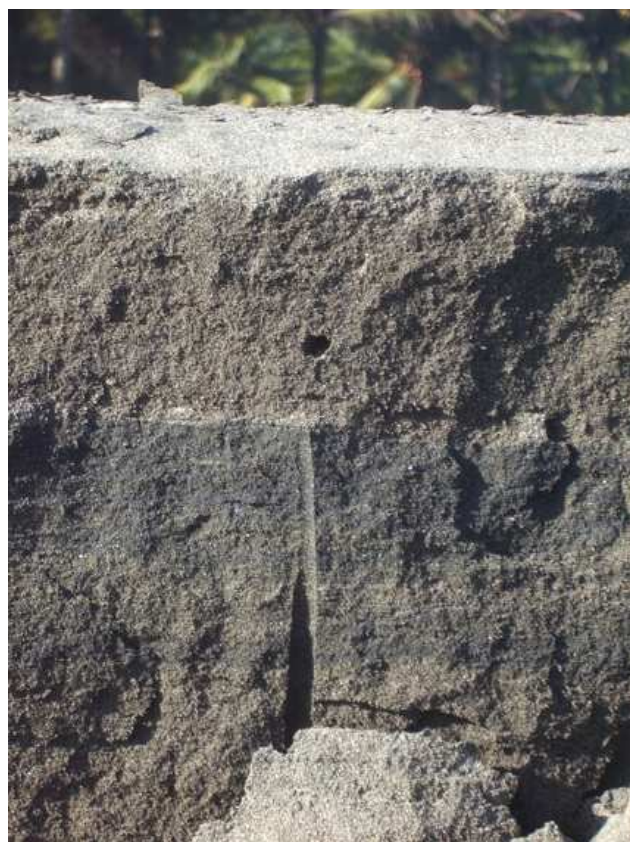
Fig. 3. Sand deposit left by the tsunami.

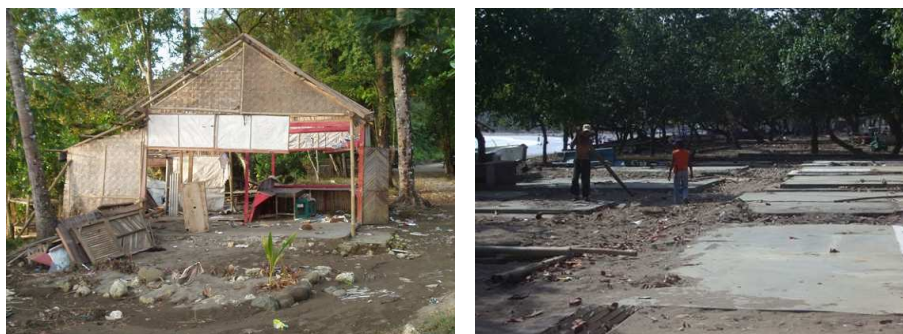
Performance of these structures was on average poor with a few exceptions, for instance where buildings were on strong piles. In nearly all cases a flood depth of less than a metre (above floor) caused light to moderate damage, 1.5 to 2 m resulted in roughly 70% destroyed and 30% lightly to heavily damaged but repairable, and a depth exceeding 2 m essentially caused total destruction (Fig. 11).

Fig. 11. Typical damage to semi-permanent wooden shops, after inundation to nearly 1 m depth (a) and to 3 m (b). Only the concrete floors remain in the right image, where prior to the tsunami there had been a row of more than 30 shops.

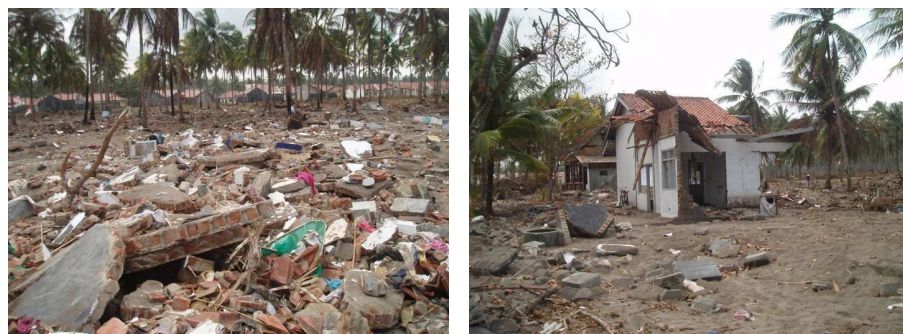
Many of the single story residential structures and shops were made of unreinforced brick walls on concrete foundations. The construction was weak, with single-skin brick walls, often plastered on both sides. The vast majority of roofs were covered with clay tiles, a few with corrugated steel sheets. The observed damage levels were not much different from the timber/bamboo ones (Fig. 12).

The main difference was that slightly more houses remained upright where the flood depth was greater than 2 m. But most of them seemed not repairable apart from the concrete floor which often remained intact.

Fig. 12. The remains of traditional brick houses after inundation to a depth of ca. 3 m (a). There were a few partially intact (b).

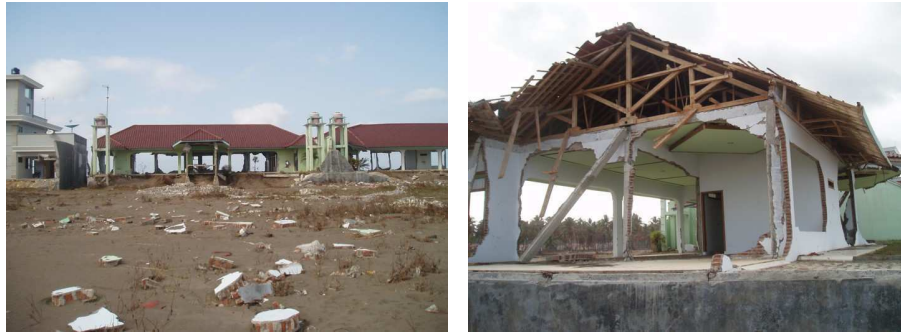
The non-engineered masonry structures had rudimentary reinforced concrete columns, and single-skin infill brick walls that were often plastered on both sides. Buildings typically had concrete floors and were one and two-storey houses and shops. Columns ranged from 100 mm×100 mm with 4 wires of 3 mm diameter, to 200 mm×200 mm with 4 smooth bars of 8 to 12 mm diameter at the four corners. The walls suffered punching shear failure, often with holes punched through multiple walls. Even though the reinforcement was rudimentary, it improved the performance significantly. The observed damage levels were

- <1 m of water – minor damage only,
- 1.5 to 2 m of water – light to moderate damage (repairable), and
- 3 to 4 m of water – serious damage, but buildings upright and probably repairable (Fig. 13).

Fig. 13. Two relatively well-made apartment complexes (a) with rudimentary reinforced concrete columns (b), after inundation to a depth of 3.8 m.

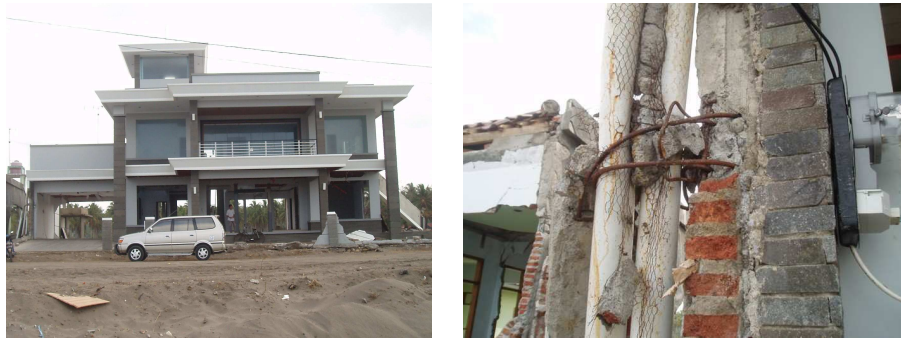
These robust constructions were the predominant structure type for hotels, but also some shops and houses. Often with two or more storeys, they had brick infill walls with plastering on both sides, reinforced concrete columns of at least 200 mm×200 mm, at least 6 bars of 12 mm reinforcement, and concrete floors. These well-constructed and reinforced buildings survived the tsunami with minor damage only. Damage was often limited to broken windows and

doors or failed first floor walls which could be due to the effect of debris. Observed damage levels were:

- <1 m of water – zero to light damage to ground floor,
- 1.5 to 2 m of water – light to moderate damage to ground floor (repairable), and
- 3 to 4 m of water – moderate damage to ground floor (holes punched through 1 or more walls), but building upright and repairable (Fig. 14).

Fig. 14. Well engineered beachfront villa after inundation to a depth of 3.8 m (a). Reinforcement detail is shown at right (b).
